WHEELER TECHNOLOGY INC.

March 15, 1991

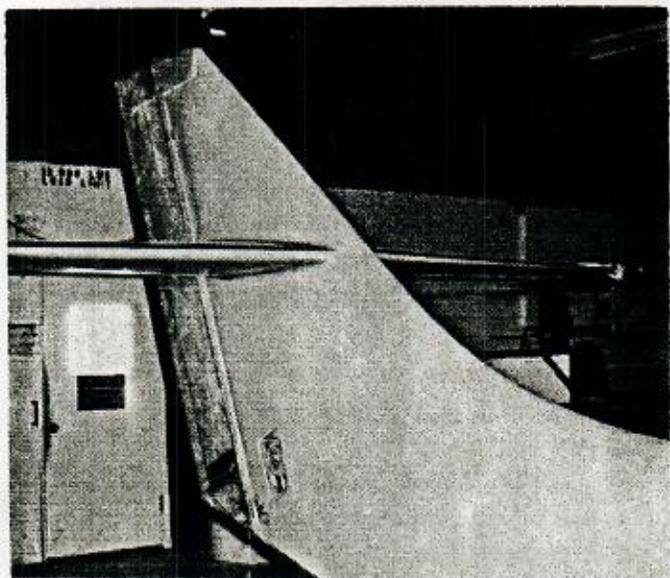
NEW FACTORY DEMO

Compare the angles of incidence of the horizontal stabilizers of C-GUPZ and the new factory demonstrator. These photos are nearly identical in size and perspective (GUPZ' rudder turned toward camera). The angle of C-GUPZ is clearly positive (leading edge rotated up) in comparison.

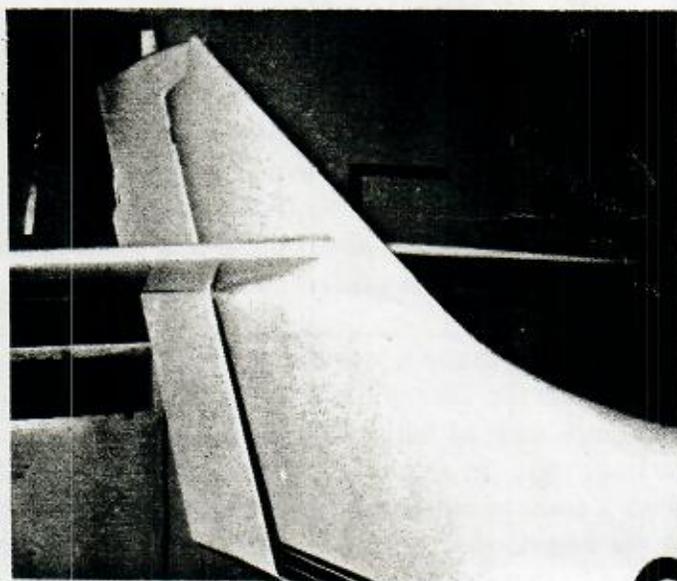
C-GUPZ

said that Mr. Betts had stated that he set the angle of incidence of the horizontal stabilizer at eight degrees and he complained that the fit of the tail section to the fuselage was very poor, so he had to do a lot of work to make it fit. One look at the photos confirms the positive angle, explains why he had difficulty fitting the tail to the fuselage, why he cut it off, why he needed ballast, the reason for his trim problem and high landing speeds, and even explains his "vibration in the empennage".

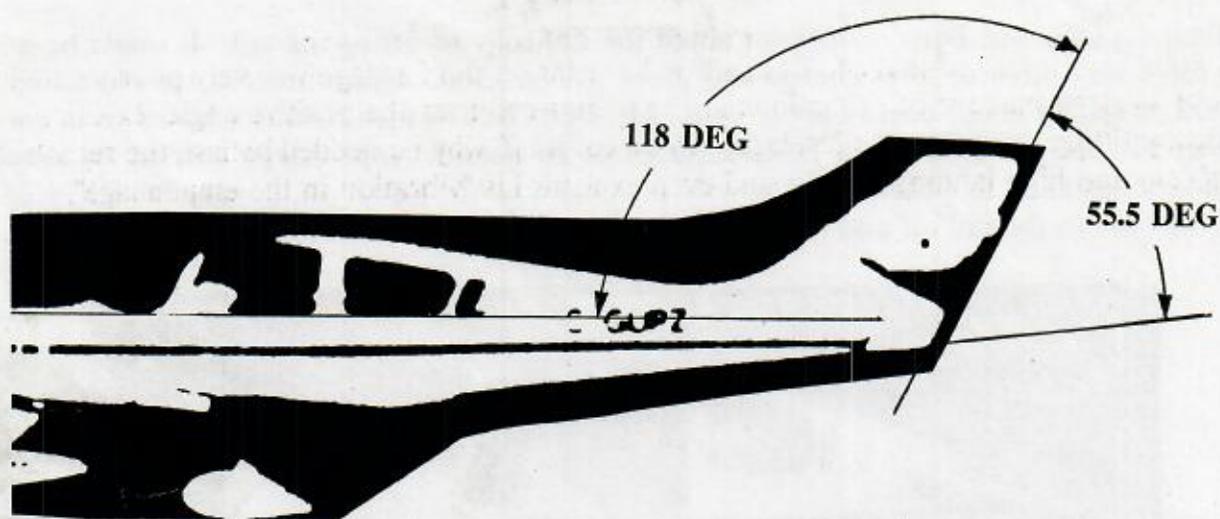
PHOTO COPIER-ENLARGED PHOTOGRAPH OF C-GUPZ

The correct angle between the window line and rudder edge is 115 degrees, which for reference, is what N210EX measures in the centerpiece photo in the AOPA magazine reprint. However, in the photos of Mr. Betts' plane, that angle measures approximately 118 degrees, which means Mr. Betts' horizontal stabilizer angle of incidence was in error approximately three degrees in the positive direction (leading edge up), which is a very significant deviation. As a check, the design angle between the fuselage bottom and the rudder edge is 58.5 degrees; Mr. Betts' plane measured 55.5 degrees, confirming the three degree change.

Three degrees may not sound like much, but over a length of 37 inches, (the root chord of the stab/elevator), the difference would be nearly two inches at the leading edge if the stab were rotated around the trailing edge. The deviation means Mr. Betts' horizontal stabilizer was not producing the down force it's designed to do, which is a dangerous condition possibly resulting in deep stall and a variety of other problems. It would require a major adjustment to the trim system to counter that force, and would limit elevator authority, requiring higher landing speeds. Obviously, ballast is a poor solution, working only in a narrow speed range, because the up force varies with speed, while the ballast remains fixed in weight and location. It also means that because of the angle of the stabilizer and the amount of up elevator required to trim the plane, turbulent flow would be very likely in some conditions, and possibly a stalled stabilizer or elevator. Either of those could and most probably would produce buffeting or "empennage vibration", but flutter is not dependant on the angle of incidence and is therefore unlikely.

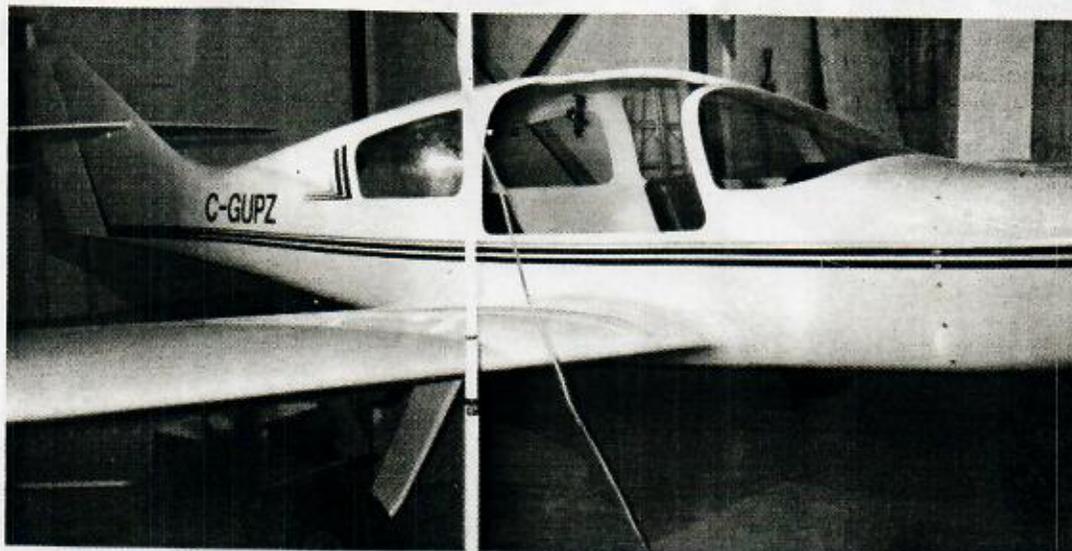
In this photo of GUPZ, the positive stab angle is also quite evident. For reference, the visible bottom of the fuselage is a waterline, which of course means that it is at zero degrees. The door sill also makes an easy and known reference.
