FLIGHT SAFETY MESSAGE

EXPRESS AIRCRAFT CO LLC

NUMBER 980001
January 31, 1998

SUBJECT: MAIN LANDING GEAR INBOARD ATTACHING BRACKET

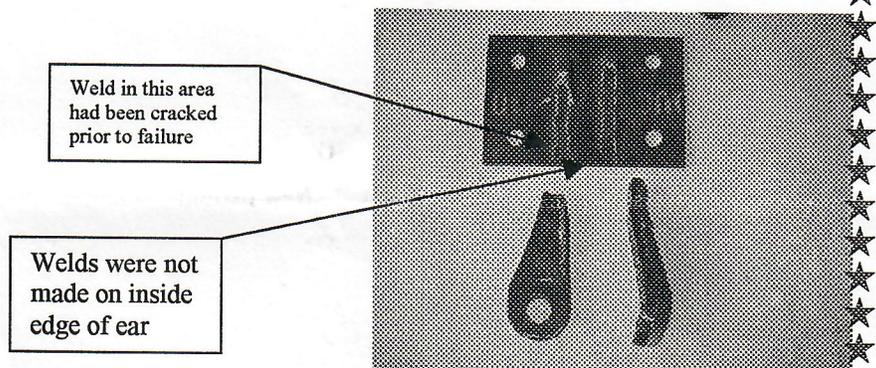
Two incidents have been reported involving failure of the main landing gear bracket (part number 115-14-004). In both cases the aircraft were equipped with the EDI steel gear and IO540 engines. One aircraft was the S90 version and the other a CT. The inboard bracket failed on landing, resulting in the inboard end of the main landing gear puncturing a hole in the lower wing skin. This allowed the wing to settle until the wheel pant came in contact with the wing. No additional damage was done to the aircraft.

Investigation indicates that the bracket is failing because of increased horizontal loads caused by the wider wheelbase of the EDI steel main landing gear and the higher gross weights, at which the aircraft is operating. In addition, an inspection of several brackets indicated less than satisfactory manufacturing procedures.

1. Immediate inspection of both inboard landing gear brackets for cracks in the welded areas. If the bracket installed does not have both sides of the ear welded, bracket should be replaced immediately.
2. Follow-up inspections should be conducted in 10 hour intervals and after every incident of hard braking.
3. Bracket should be replaced immediately if any defect is found or during the next scheduled condition inspection, which ever occurs first.

Replacement brackets are available. These brackets have additional gussets to absorb the increased horizontal loads and are normalized and heat treated. For additional information contact Larry Olson, Express Aircraft Co. (360) 352-3554.
