## WHEELER TECHNOLOGY INC.

March 15, 1991

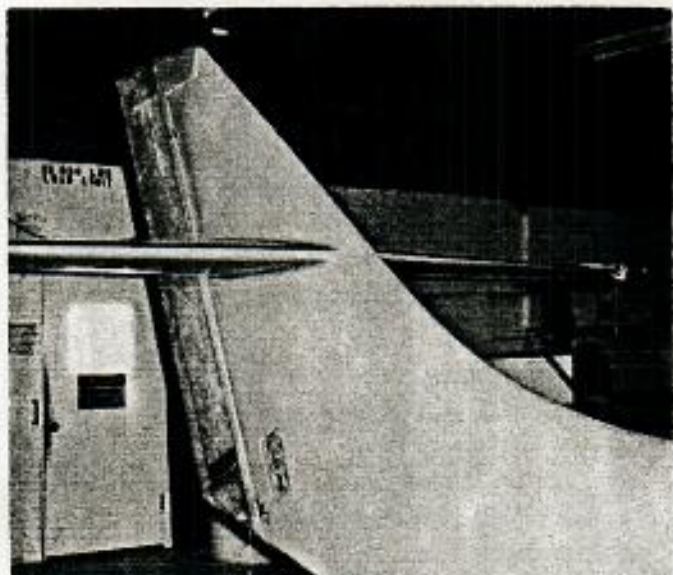
NEW FACTORY DEMO

Compare the angles of incidence of the horizontal stabilizers of C-GUPZ and the new factory demonstrator. These photos are nearly identical in size and perspective (GUPZ' rudder turned toward camera). The angle of C-GUPZ is clearly positive (leading edge rotated up) in comparison.

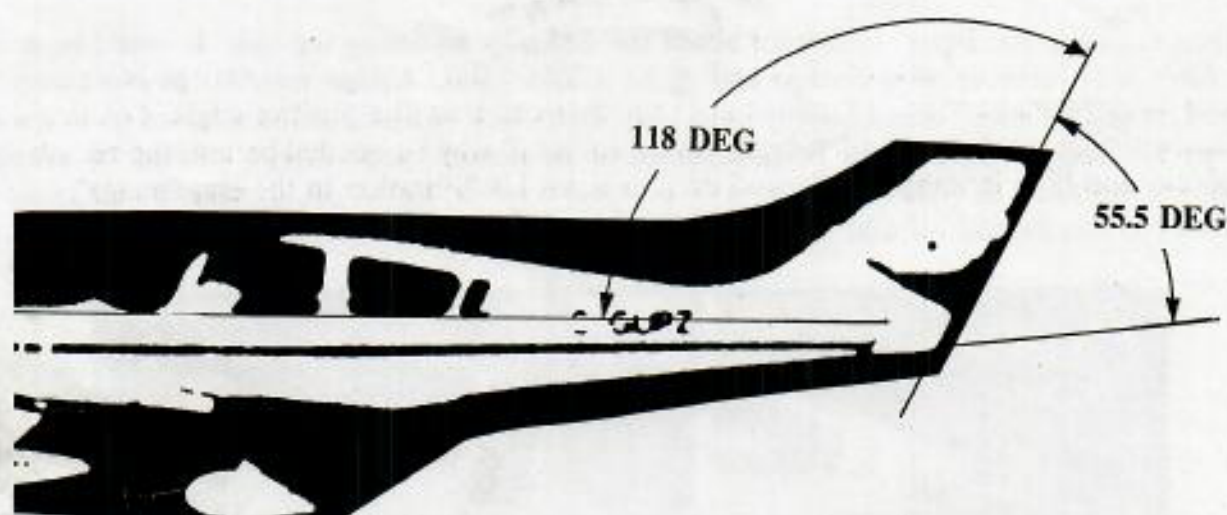
PHOTO COPIER-ENLARGED PHOTOGRAPH OF C-GUPZ

The correct angle between the window line and rudder edge is 115 degrees, which for reference, is what N210EX measures in the centerpiece photo in the AOPA magazine reprint. However, in the photos of Mr. Betts' plane, that angle measures approximately 118 degrees, which means Mr. Betts' horizontal stabilizer angle of incidence was in error approximately three degrees in the positive direction (leading edge up), which is a very significant deviation. As a check, the design angle between the fuselage bottom and the rudder edge is 58.5 degrees; Mr. Betts' plane measured 55.5 degrees, confirming the three degree change.

Three degrees may not sound like much, but over a length of 37 inches, (the root chord of the stab/elevator), the difference would be nearly two inches at the leading edge if the stab were rotated around the trailing edge. The deviation means Mr. Betts' horizontal stabilizer was not producing the down force it's designed to do, which is a dangerous condition possibly resulting in deep stall and a variety of other problems. It would require a major adjustment to the trim system to counter that force, and would limit elevator authority, requiring higher landing speeds. Obviously, ballast is a poor solution, working only in a narrow speed range, because the up force varies with speed, while the ballast remains fixed in weight and location. It also means that because of the angle of the stabilizer and the amount of up elevator required to trim the plane, turbulent flow would be very likely in some conditions, and possibly a stalled stabilizer or elevator. Either of those could and most probably would produce buffeting or "empennage vibration", but flutter is not dependant on the angle of incidence and is therefore unlikely.

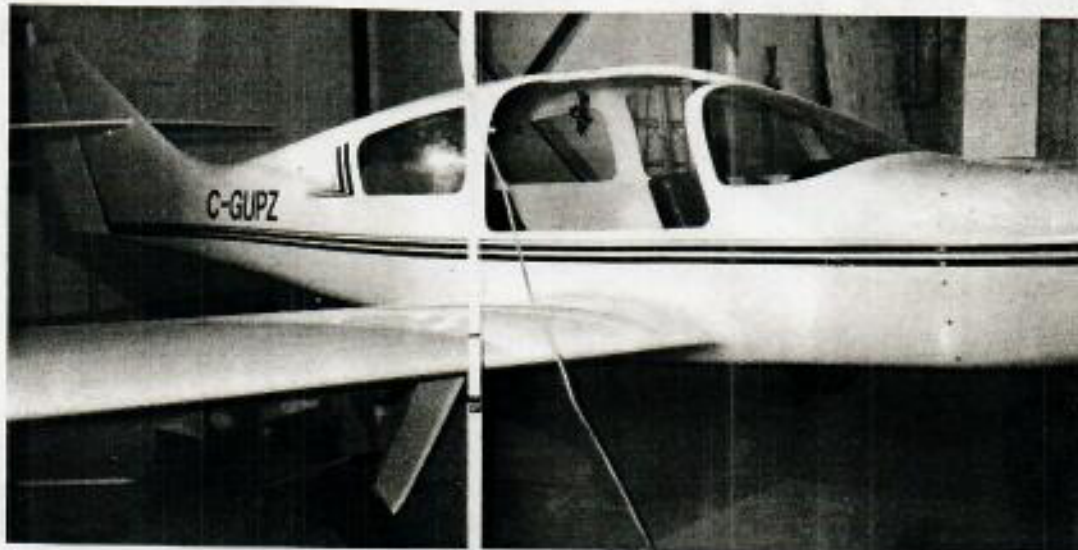
In this photo of GUPZ, the positive stab angle is also quite evident. For reference, the visible bottom of the fuselage is a waterline, which of course means that it is at zero degrees. The door sill also makes an easy and known reference.
