EXPRESS

BY BRIEN A. SEELEY, C.J. STEPHENS AND THE CAFE BOARD

FLYING QUALITIES REPORT EXPRESS N360EZ

BY C.J. STEPHENS
CAFE FOUNDATION TEST PILOT

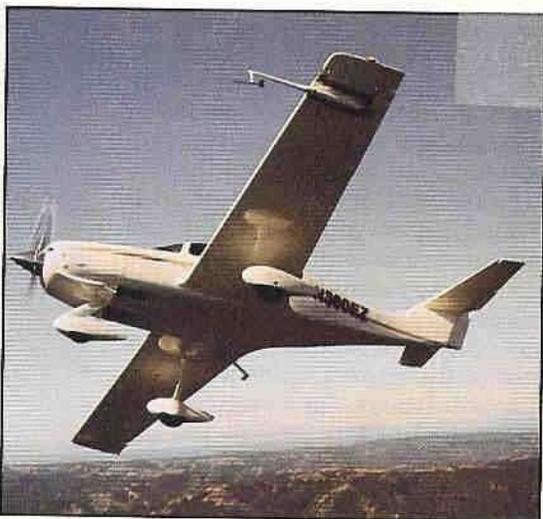
The Express has a cruciform horizontal tail with sweepback.

The cruciform tail (mid-mounted horizontal stabilizer), wide tapering fuselage and highly swept vertical stabilizer combine to produce low yaw stability. This was evident during dynamic testing, high angles of attack, and during excursions into high yaw situations at one G. An uncommanded right yaw with inadequate elevator control occurred after 1 G clean stalls and persisted until airspeed over 85 kts. had been regained. This behavior should receive more investigation by a professional test pilot wearing a parachute.

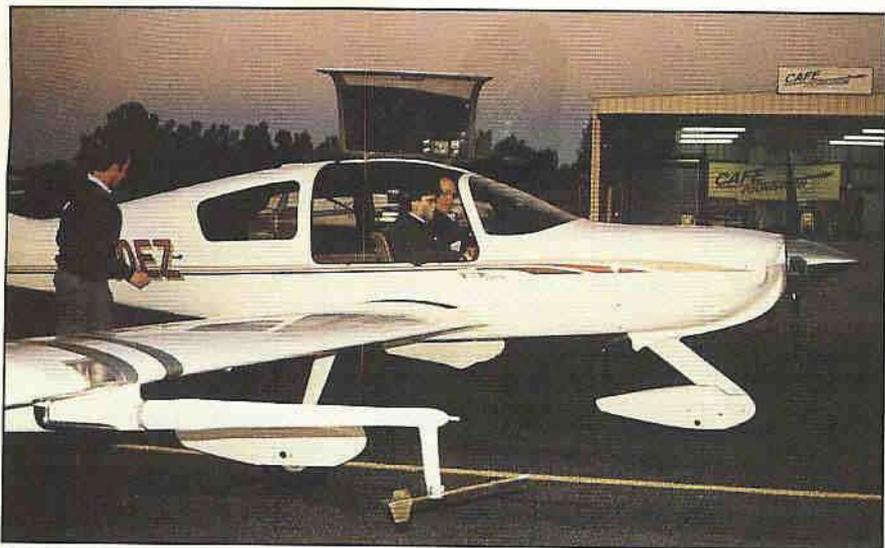
CAFE Barograph, pitot-static and boom mounted on right wing for first data flight at dawn on 9/20/97. Note large, gull-wing cabin door and rear baggage door.

Barograph #3 was used on a wing cuff mount and was compared to CAFE Barograph #1 mounted in the cabin and connected to the stock aircraft pitot static system using "T" fittings to allow the panel airspeed and altimeter to indicate their normal readings. These three airspeed system's data appear in the calibration table in this report. Compensation was made for the drag of the wing cuffs in determining the cruise speeds published here.

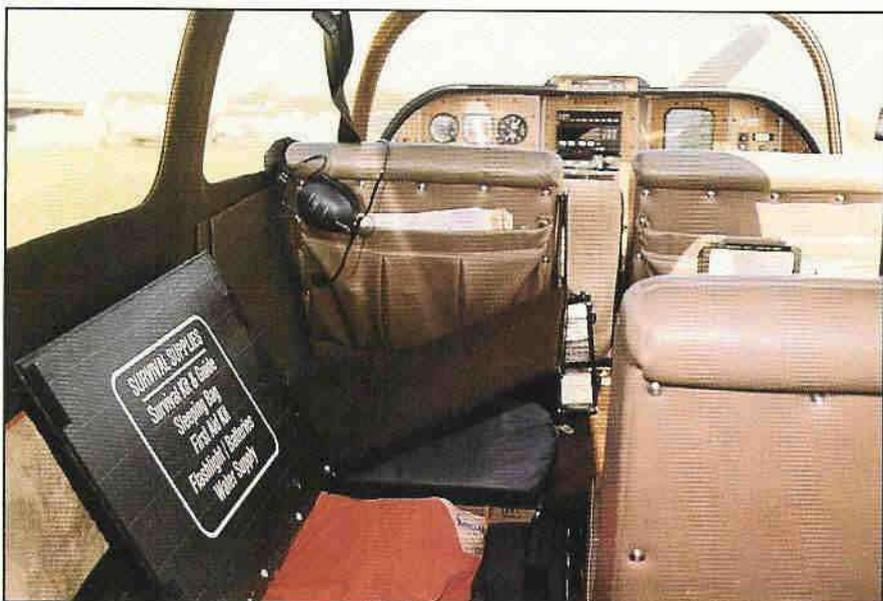
N360EZ's cabin had a flat floor covering two storage bays and could be used as a 74" long bed. A 4th seat could be installed as an alternative.

Jerry designed the seats for quick removal and created a nifty cabin layout allowing three seats and a 74" long litter/baggage floor area underneath which are two large storage bays. These bays were covered by carpeted graphite floor panels (see photo).

One very nice and unusual feature of the aircraft design was the tremendous amount of leg room in the back seats. It measured 74" from the back of the front seats to the baggage compartment bulkhead. The owner had even built a litter type of installation that could be used with a sleeping bag

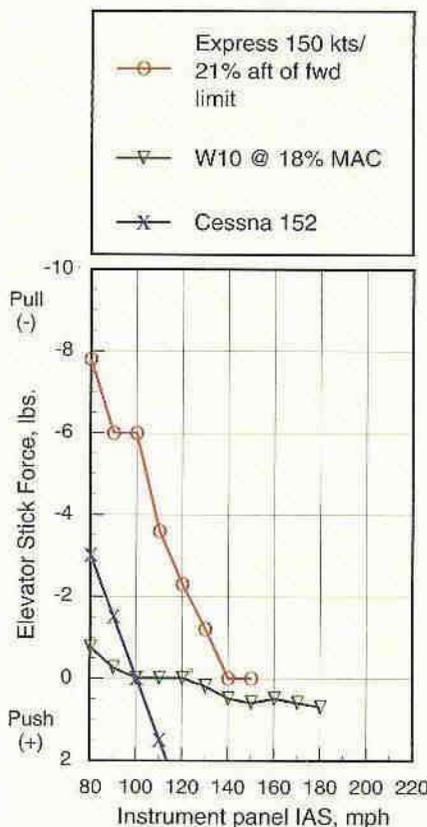
Static longitudinal stability
trimmed hands-off at V_a

At 7,500 ft. altitude the airplane was trimmed to "hands off" at 150 kts. Without retrimming, measurements were taken of the stick force required to hold level flight at each 10 kt increment of all attainable airspeeds. The graph shows the results of these samples.

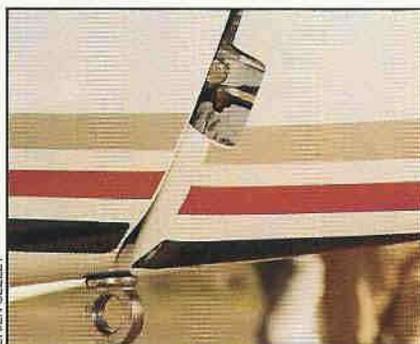
A rudder stop bolt was set to limit travel to 20° on each side.

The rudder, as tested, was set to allow up to 26 degrees deflection per the construction manual. Use of this large amount of deflection, when combined

with the low yaw damping, seemed to set up a partial stall of the vertical fin, further compounding the yaw instability. Interview with the owner indicated that some prior testing of this had been done with a video camera and tufts and those tests had confirmed poor airflow over significant portions of the vertical tail. The construction manual allows that the rudder deflection can be set as low as 20 degrees maximum deflection. From my observations this would seem to me to be a more desirable setting.

The owner, Jerry Sjostrand, returned to the CAFE Foundation test facility nearly one month following completion of our tests on his airplane to further study the problems in stability that were discussed here. He had, since the original visit, reduced the amount of rudder travel from 26 degree deflection to 20 degrees deflection. This lower setting was allowed in the basic construction manual. Jerry had requested that I re-evaluate the handling qualities with this lower rudder deflection and report any changes this had produced.

There was definite improvement with the lower rudder deflection limits. All of the original characteristics were exhibited again but to a lesser degree. As with the previous testing in level, fixed heading, uncoordinated flight, the nose position would drop increasingly as the rudder input was increased beyond 2/3 deflection. This tendency could now be adequately countered with aft stick to hold the nose up. Prior to resetting the rudder to the lower stop position the airplane would simply run out of up elevator in this condition. The elevator was now sufficient to hold the nose in level flight even with full rudder deflections.
